RESTORATION

OF THE ST. GEORGE'S CATHEDRAL

8TH JANUARY 2025 - 1ST NOVEMBER 2025

ST. GEORGE'S CATHEDRAL
CHENNAI

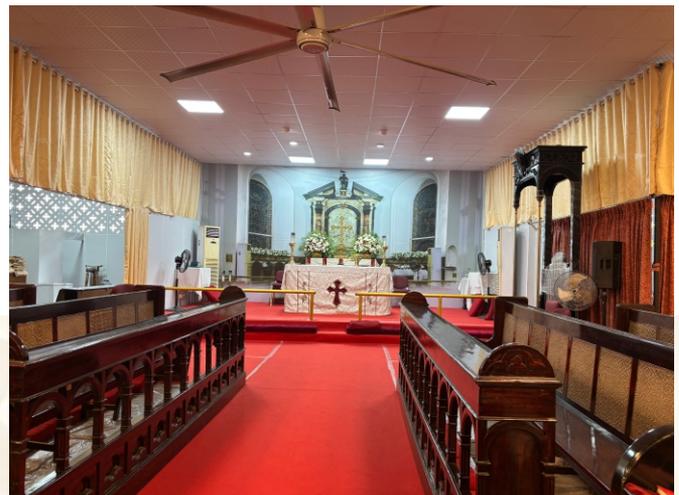
The temporary Church structure

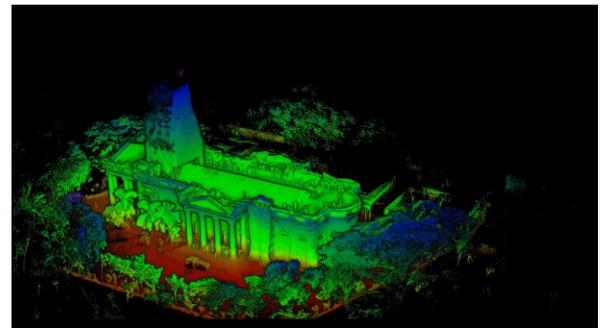
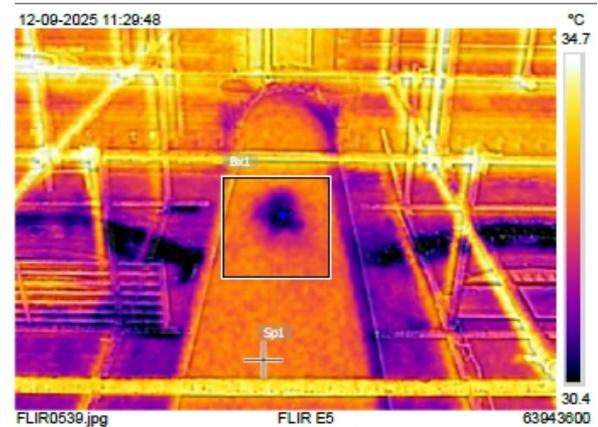
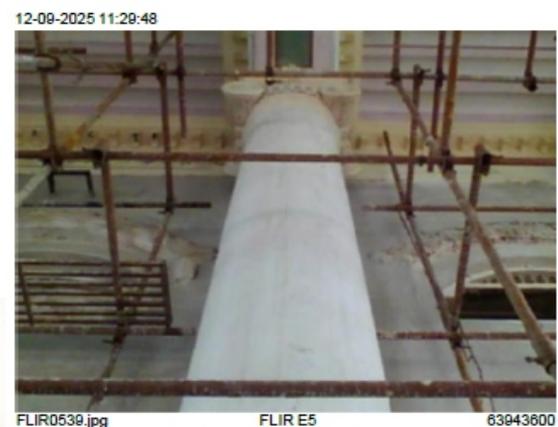
Infrared thermography identifies trapped moisture

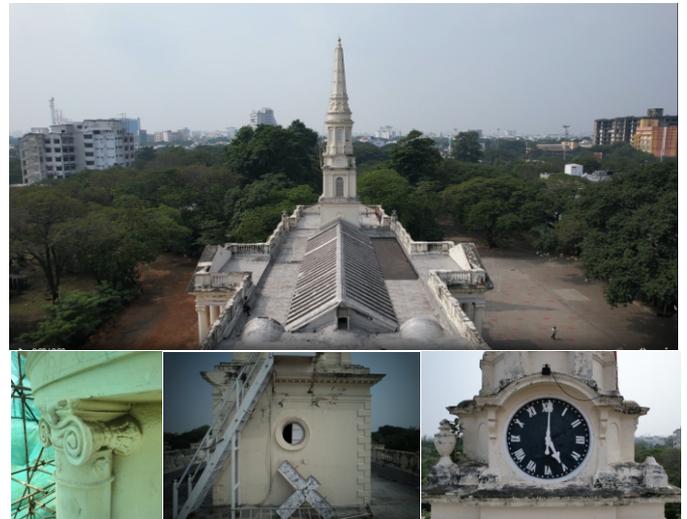
Vegetation growth on terraces, cornices, and steps was addressed through a controlled chemical and mechanical removal process. Plants were injected at the root zone with an approved chemical solution to ensure complete drying and to prevent regrowth. After a few hours, the dried vegetation and root systems were carefully removed without damaging the surrounding masonry. Voids and cavities formed by root penetration were cleaned and filled with lime grout to restore surface integrity and prevent moisture ingress.

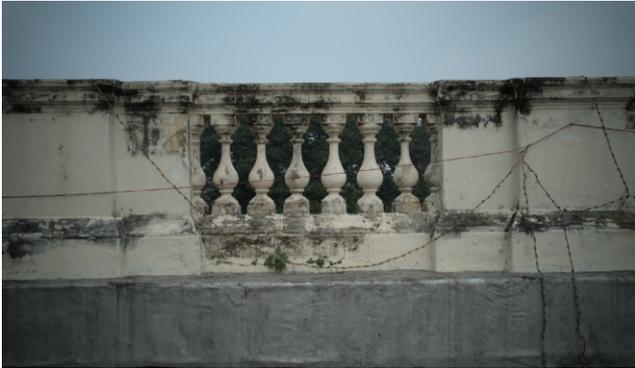
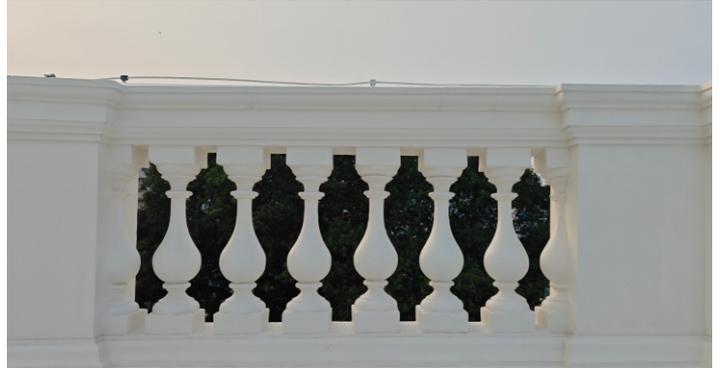
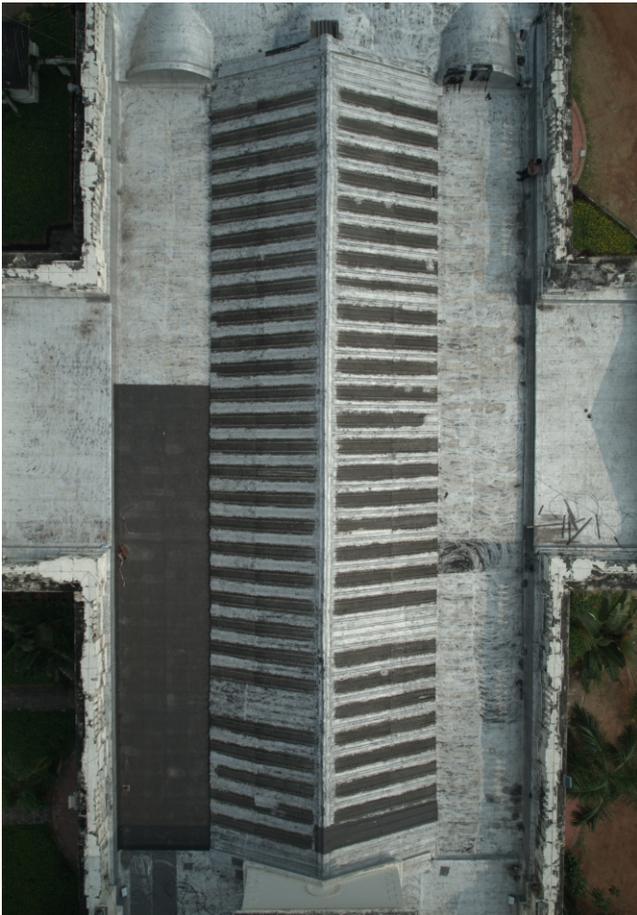
Before and After

Parapet Baluster Restoration: Condition assessments revealed significant deterioration in some balusters. Severely damaged balusters were replaced with cement replicas cast in halves using fibre moulds derived from original lime-plastered balusters. Stainless steel rods coated with Paraloid B-72 were embedded centrally for reinforcement. Balusters in fair condition were repaired using lime mortar patching to achieve a uniform surface for finishing. Original dimensions and profiles were maintained to ensure structural and visual consistency.

Roof Installation: The original asbestos roof above the nave was replaced with Kingspan Jindal PUFF panels with galvalume steel for enhanced insulation. The curb walls beneath the eaves were rebuilt with increased height to prevent rainwater ingress, and Kerala teak blocks were installed along alternate purlins to support the new panels while maintaining the original roof slope.

Terrace Slope Correction and Screeding: Rainfall analysis and site assessment indicated the need for additional drainage. The terrace was cleaned, and slopes were re-proportioned for efficient water flow. Cement screeding was applied over RCC areas, while lime concrete was used for traditional sections. Cracks were grouted with epoxy and brick bats, and button markers ensured accurate slope levels. Flashing was provided above the drainpipe mouths, and the terrace was finished with epoxy waterproofing.

Down Take and Lead Pipes: Damaged or clogged lead pipes were replaced with PVC pipes of equivalent diameter. The surrounding brickwork was carefully chipped and packed with lime mortar and brick bats. Bell mouths were created around pipe entries to ensure efficient water flow and prevent future blockages.

Parapet Wall Crack Repairs: Cracks less than 3 mm were filled with lime mortar, while larger cracks were stitched using brick and grout. Loose plaster and decayed timber within masonry were removed carefully, and decayed timber rafters were replaced with treated seasoned hardwood. Cracked brick masonry was re-laid with lime mortar and finished flush with existing profiles. The restored surfaces were completed with lime plaster to maintain breathability and visual continuity.

West Portico Terrace Crack Restoration: Detailed documentation, careful dismantling, timber replacement, masonry repair, and final lime plaster finishing were carried out to restore horizontal cracks up to 5" in width, integrating repairs seamlessly with surrounding masonry while maintaining structural integrity and heritage authenticity.

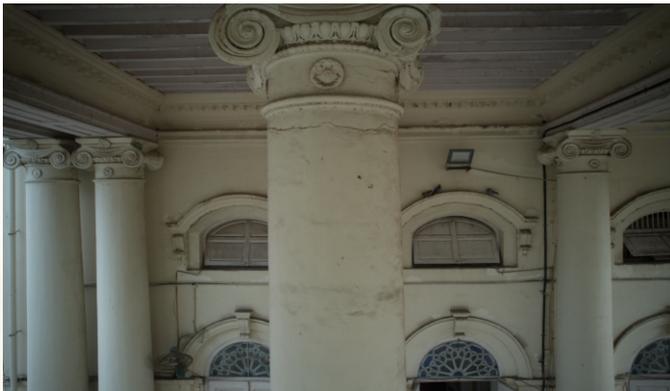
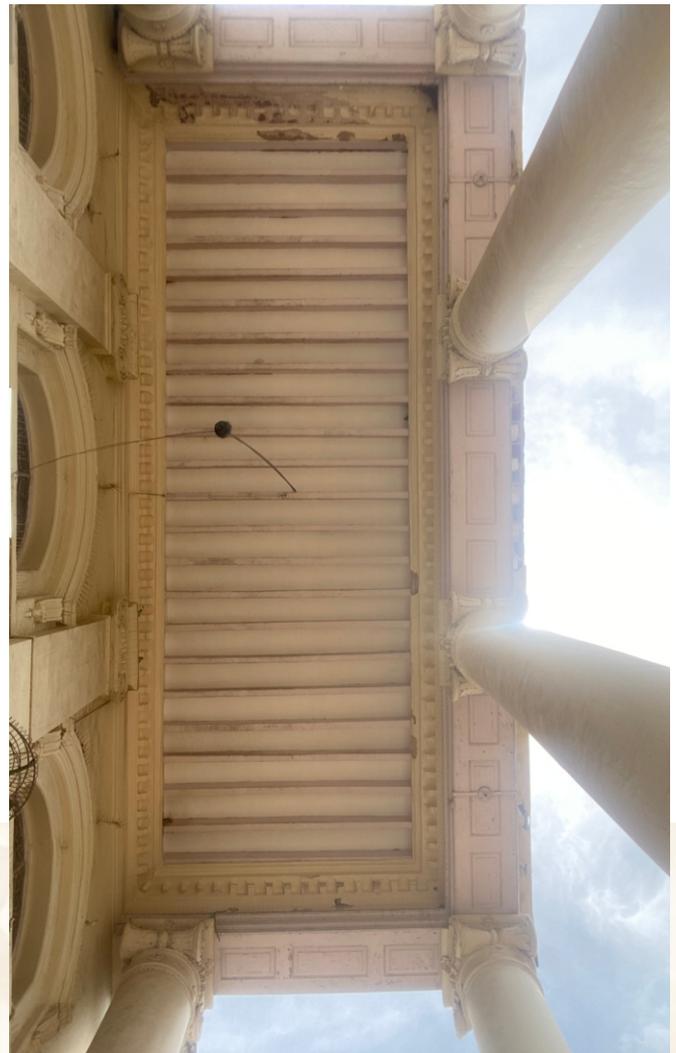
A total of nine beams in the porticos of the church were found to be in a significantly deteriorated state due to termite attack and hence required additional strengthening. After the bottom panels were removed, it was discovered that the gap between the main beam and the side panels on either side was maintained using a spacer block with iron rods holding it in place. In order to maintain the historic material value of the beams, the main beam was retained, and in the gap present between the beam and side panels on either side, an additional supporting beam was introduced along the length in these gaps with adequate bearing length. It was therefore required to remove these spacer blocks, and the iron rods were cut through gas welding. The

additional support beams were then integrated with the main beam by means of stainless-steel bolts at six locations, and new bottom panels made of the same wood were then fixed in place, covering the newly placed beam.

As the length of the rafters and beams was over 14 feet, entire logs of Burma teak of adequate length had to be procured from Mangalore and were then cut to the size and length required, without having to provide any joints in the structural timber members. They were given the required anti-termite treatment before being fixed in place.

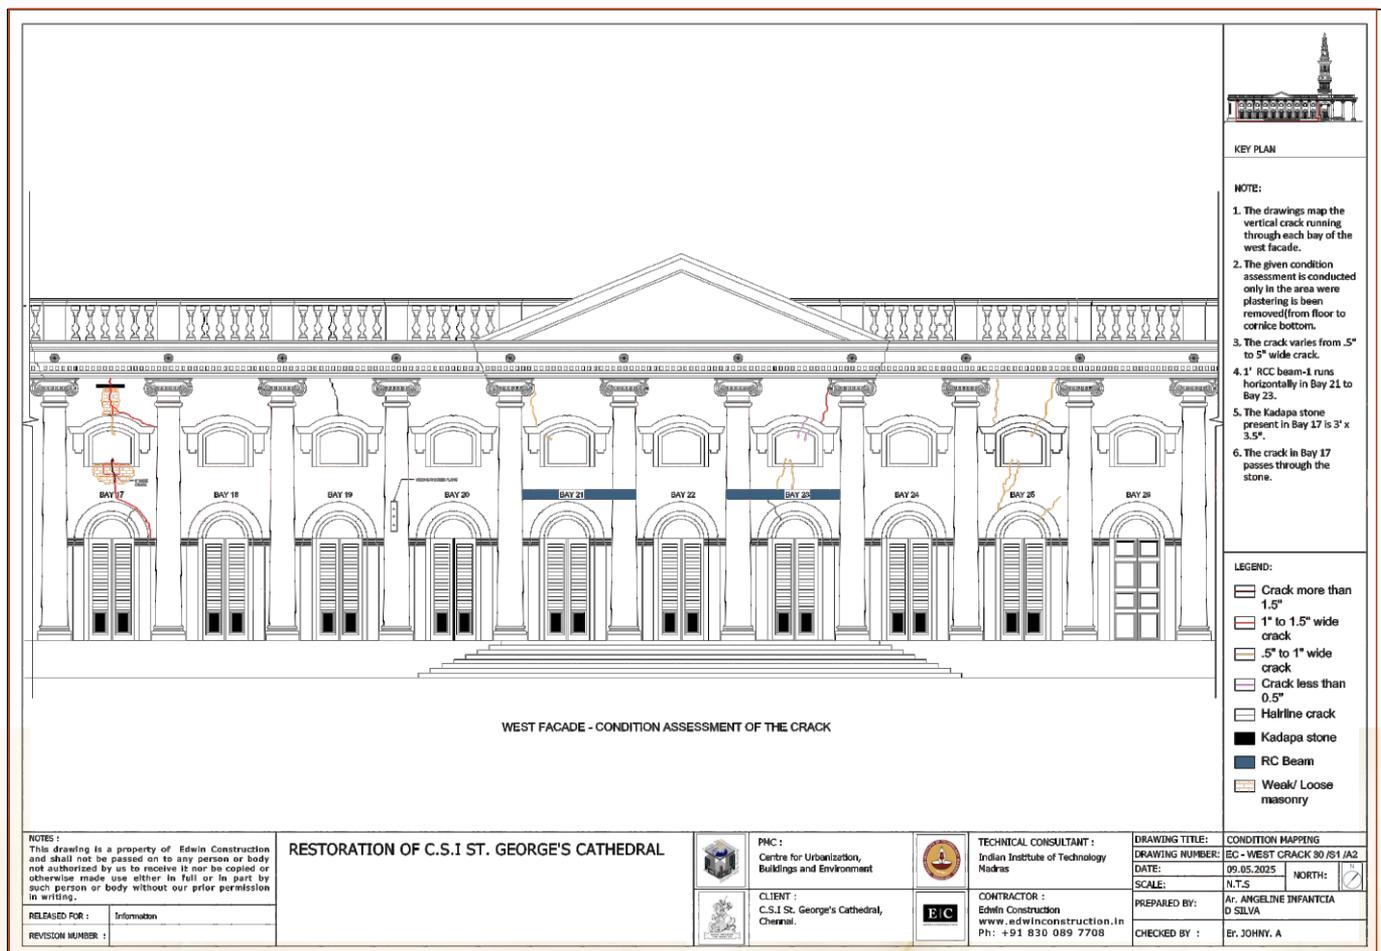
A detailed condition assessment was conducted on one bay of the external façade. During the removal of the existing wall plaster, multiple layers and material combinations were identified, and samples were collected. These included areas with complete cement plastering, areas with complete lime plastering, and locations where cement was applied over lime plaster. Following

this assessment, the walls were fully re-plastered using lime mortar after carefully removing the existing lime plaster. The RCC band of the façade revealed significant structural issues, including large cracks, which were thoroughly documented. For the wider cracks, ranging from 2–4 inches to 1–4 feet, stone stitching was carried out, and loose brick masonry was replaced through brick filling to restore structural integrity.

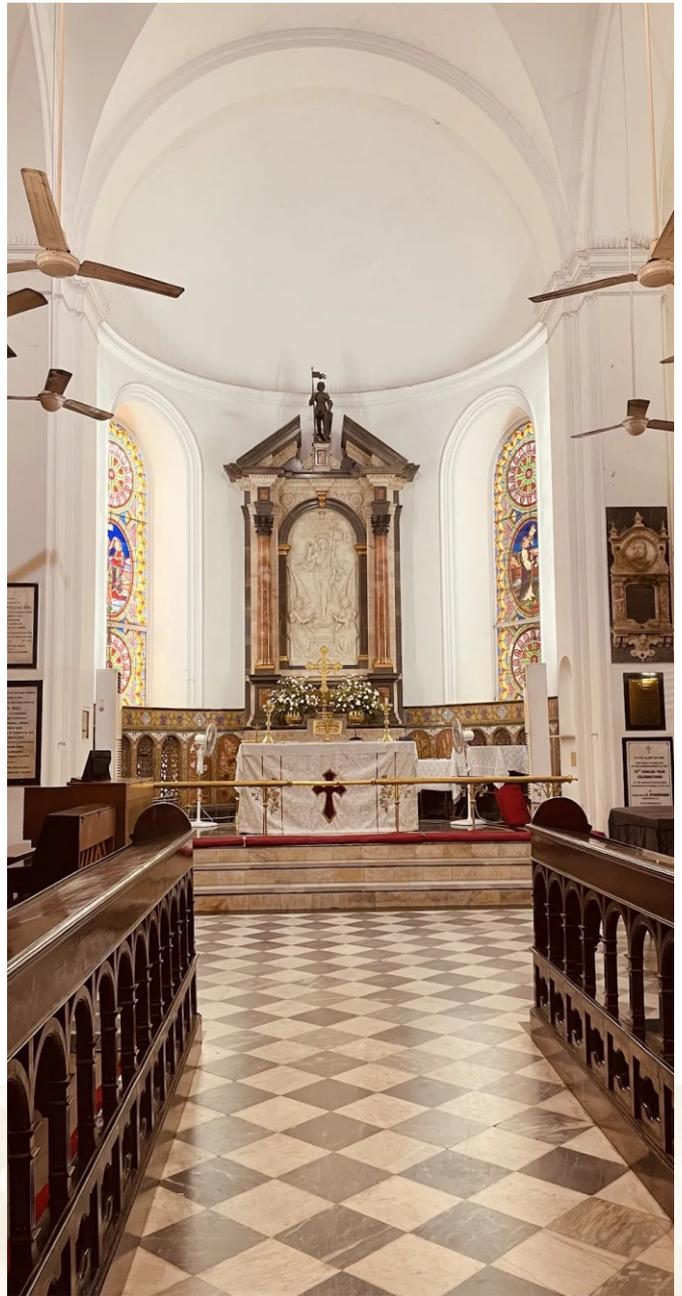
Similar to the exterior façades, condition assessment of the plaster was carried out in the interior of the church. As cement plaster was found in several areas of the church causing deterioration of the surrounding lime plaster and the underlying bricks—as cement plaster traps moisture from capillary action from the ground—the plain wall plaster was entirely removed and re-plastered with two layers of lime plaster. The decorative plaster was retained, and patchwork was done as required. Similarly, as the pedestals of the circular columns were entirely cement plastered, it was carefully chipped to expose the brick and redone with lime mortar. One of the largest challenges faced during the conservation process was the restoration of the reinforced concrete slab of the ceilings of the aisles of the church. The RC slab was introduced in the mid-20th century following the collapse of the Madras terrace, and over the decades, significant deterioration of the steel reinforcement was observed, therefore requiring additional reinforcement to be provided. After the cover concrete was removed in the areas where it was loose, exposing the reinforcement, based on the recommendations from the technical consultant and expert team advising on the same, as the reinforcement corrosion was over 30%, several trials of providing additional reinforcement were done to determine an ideal solution, and based on the outcomes, it was decided to provide shear connectors to which the reinforcement would be tied and then micro-concreting done to match the same level as the surrounding slab soffit. While this procedure was for the east aisle, for the RC slab above the west aisle, it was observed through condition assessment that the cement plaster applied below the cover concrete was weak, whereas the latter was much stronger and did not require the same methodology. Hence, the loose cement plaster layer alone was removed throughout the length of the slab, and re-plastering was done to achieve an even surface.

obscured. In certain areas where parts of the papier-mâché had detached and were missing, they were recreated using plaster of Paris, and a single coat of emulsion was painted over the ceiling

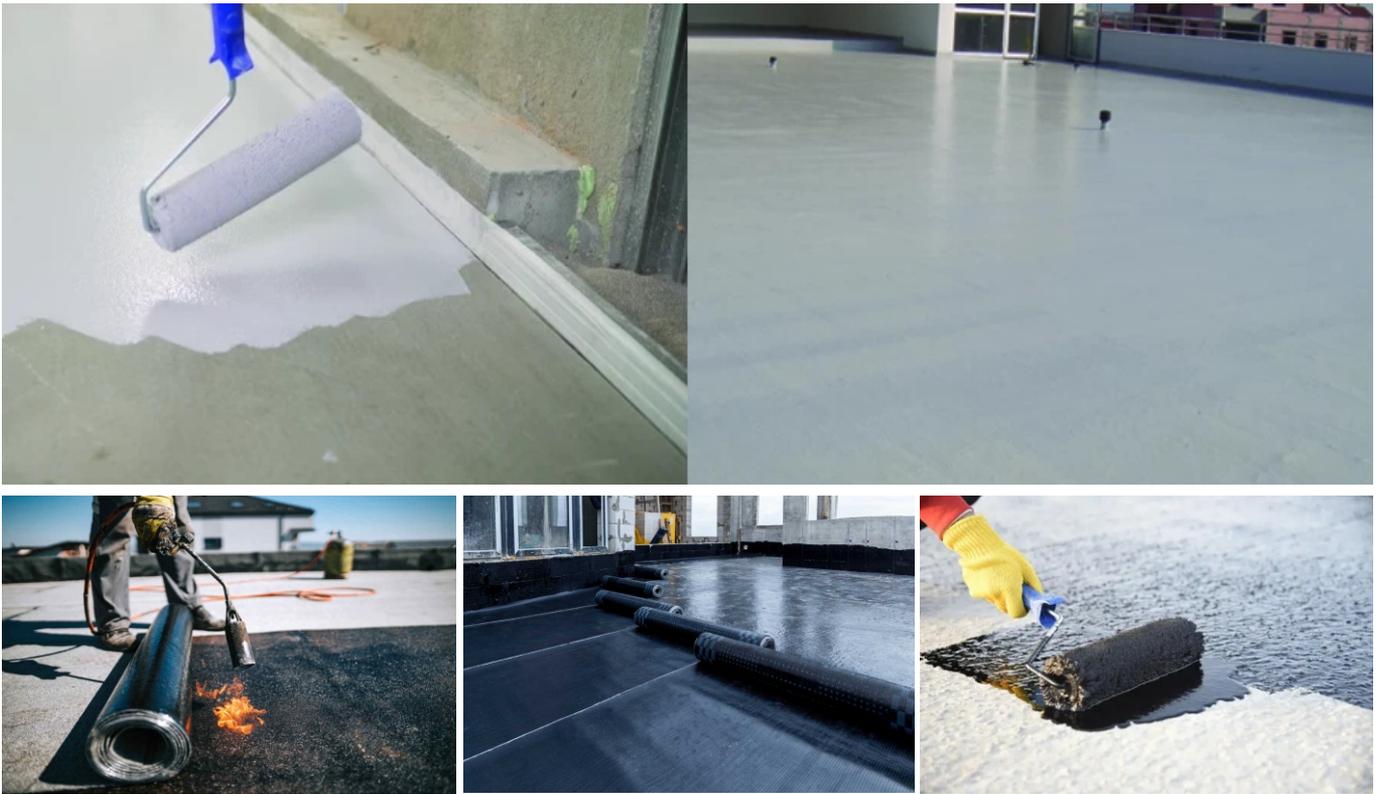
PROTECTIVE ROOF WATERPROOFING: INSULATION COATING SYSTEM

Waterproofing a heritage roof requires a careful balance between preserving the historical integrity of the structure and ensuring modern waterproofing standards. Based on two decades of technical expertise and responsibility, a comprehensive hybrid system was engineered as per the site's requirement, with elastomeric properties, high durability and excellent breathability while remaining fully waterproof and insulated even under extreme weather conditions:

I. Initial Assessment and Planning: A comprehensive, non-invasive inspection of the existing roof was conducted to diagnose the issues, and determine the original construction methods. A detailed study was conducted to grade the condition of roof substrate, slope and design. The findings were recorded and specification was engineered for long-term benefits.

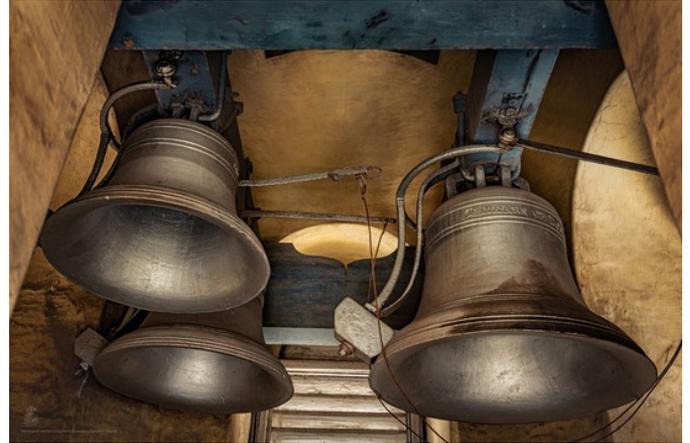
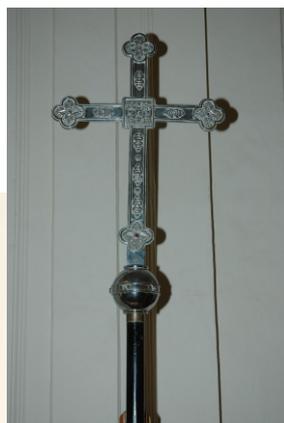
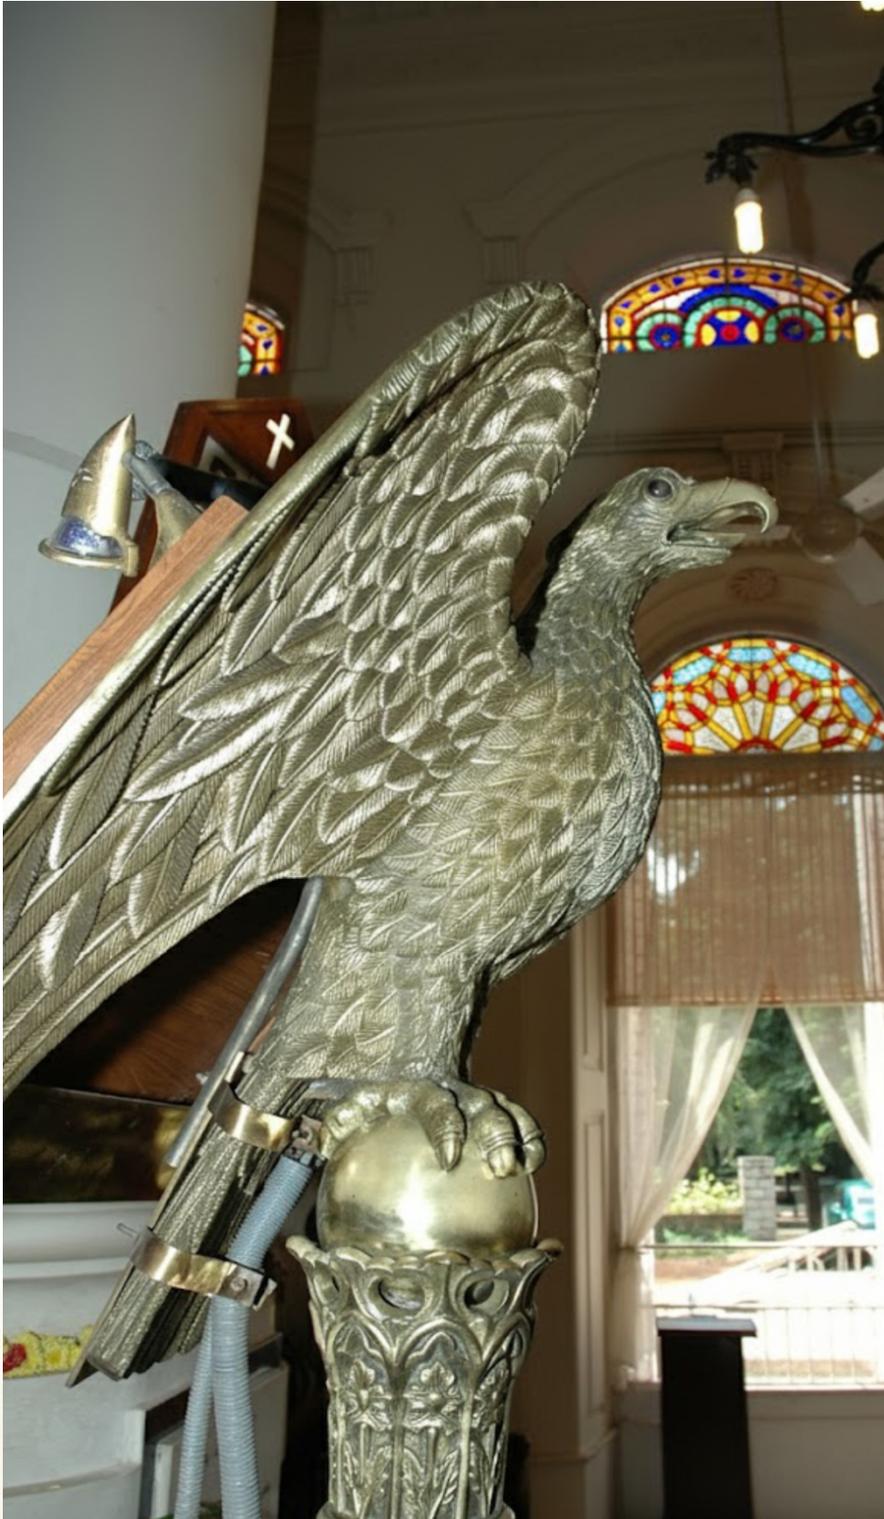
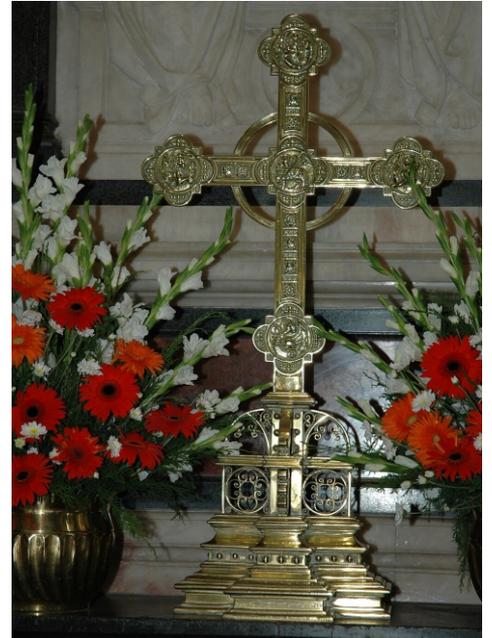
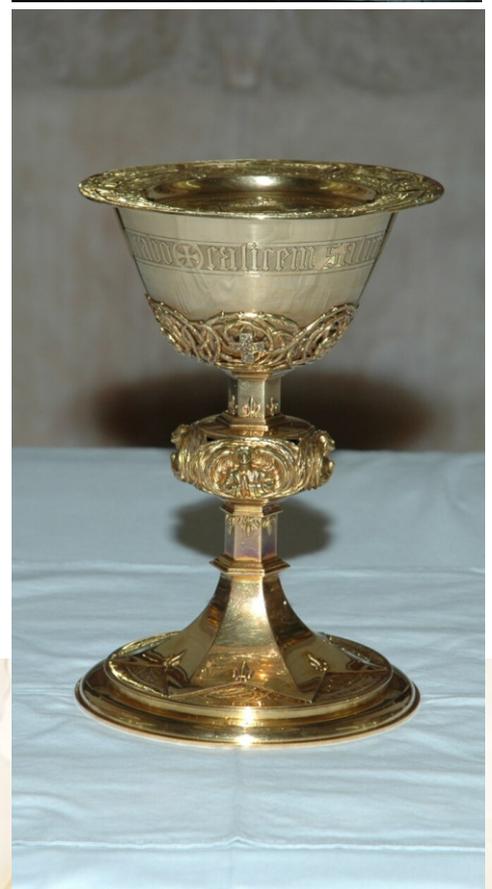
Although the marble memorials, statues, and plaques are regularly cleaned, dirt has accumulated over time due to moisture, dust, salt efflorescence, paint spills, and oil deposits. Some portions have eroded or been scratched, tablet edges have broken, and several inscriptions of sculptors' names and company details have faded. White paint residue were also found along engravings, and some plaster-bonded sections had separated or cracked, with a few pieces missing entirely. The total surface area of the marble memorials and plaques is approximately 140 sq. m.

The brass pulpit, regularly cleaned with brasso, showed blackened grooves on the eagle figure due to incomplete removal of the polish. The Cathedral houses eight bells, manufactured by Messrs Mears & Stainbank, Founders, London, in 1871. The largest bell measures 4 feet in height, 48 inches in diameter, and approximately 150 inches in circumference; the smallest measures 2 feet in height, 30 inches in diameter, and approximately 94 inches in circumference. These bells are installed within the central portion of the pinnacle, about 50 feet above ground level, mounted on one-foot-thick wooden beams in two tiers of four bells each. Made of bell metal (a copper-tin alloy with a higher tin content than bronze), they form a musical set operated by ropes. The total area is approximately 20 sq. m.

Three additional bells attached to the clock, painted silver, were found to be corroded and in need of restoration. High moisture levels had accelerated corrosion, resulting in bluish-green copper chloride deposits and accumulated dust.

The removal of accretions was planned carefully to ensure that no chemicals used during cleaning, conservation, or restoration would damage the memorials. The process included several stages: physical dusting, dry brushing, cleaning with distilled water, washing with *Extran* (a neutral soap solution), gentle abrasion with pumice stone powder (an extrusive igneous rock that softly removes surface accretions), and finally, an application of 5% hydrogen peroxide solution. After cleaning, each memorial was rinsed with distilled water and dried thoroughly.

Loose brass plaques were immersed in a 5% lemon juice or citric acid solution, then brushed, rinsed thoroughly with distilled water, and dried. This method effectively removed corrosion and restored surface sheen.

The brass pulpit, composed of three sections—the base stand, the eagle, and the reading platform—was dismantled, and each component was immersed in a suitable solvent to remove corrosion. The lower section and the eagle figure were soaked in a lemon juice solution, then brushed, washed with distilled water, and dried. Finally, they were polished with brass polish. Smaller metal objects such as lamps, flower vases, crosses, and other church vessels were similarly treated.

Dust was first removed from the bells using a dry brush, followed by cleaning with distilled water. Dirt and fungal growths were eliminated with ethanol. Corrosion products such as copper chloride were treated using ammonia, which reacts to form a copper-ammonium complex. The bells retained a uniform patina of copper oxide and carbonate, preserved for their antique finish.

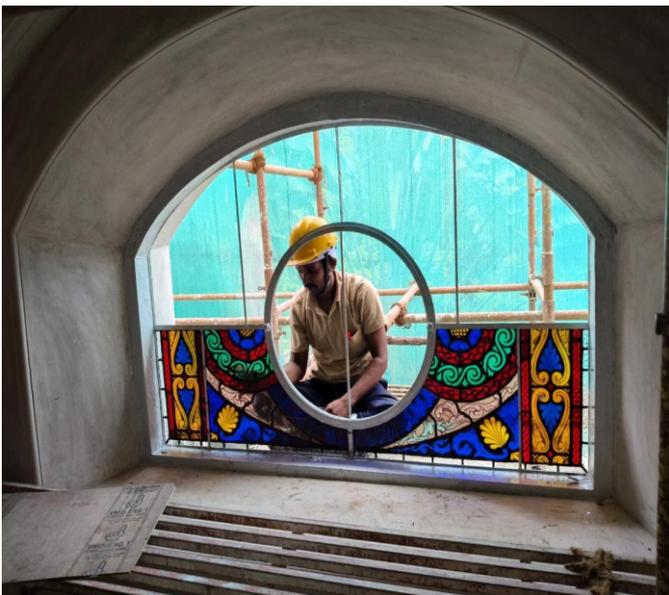
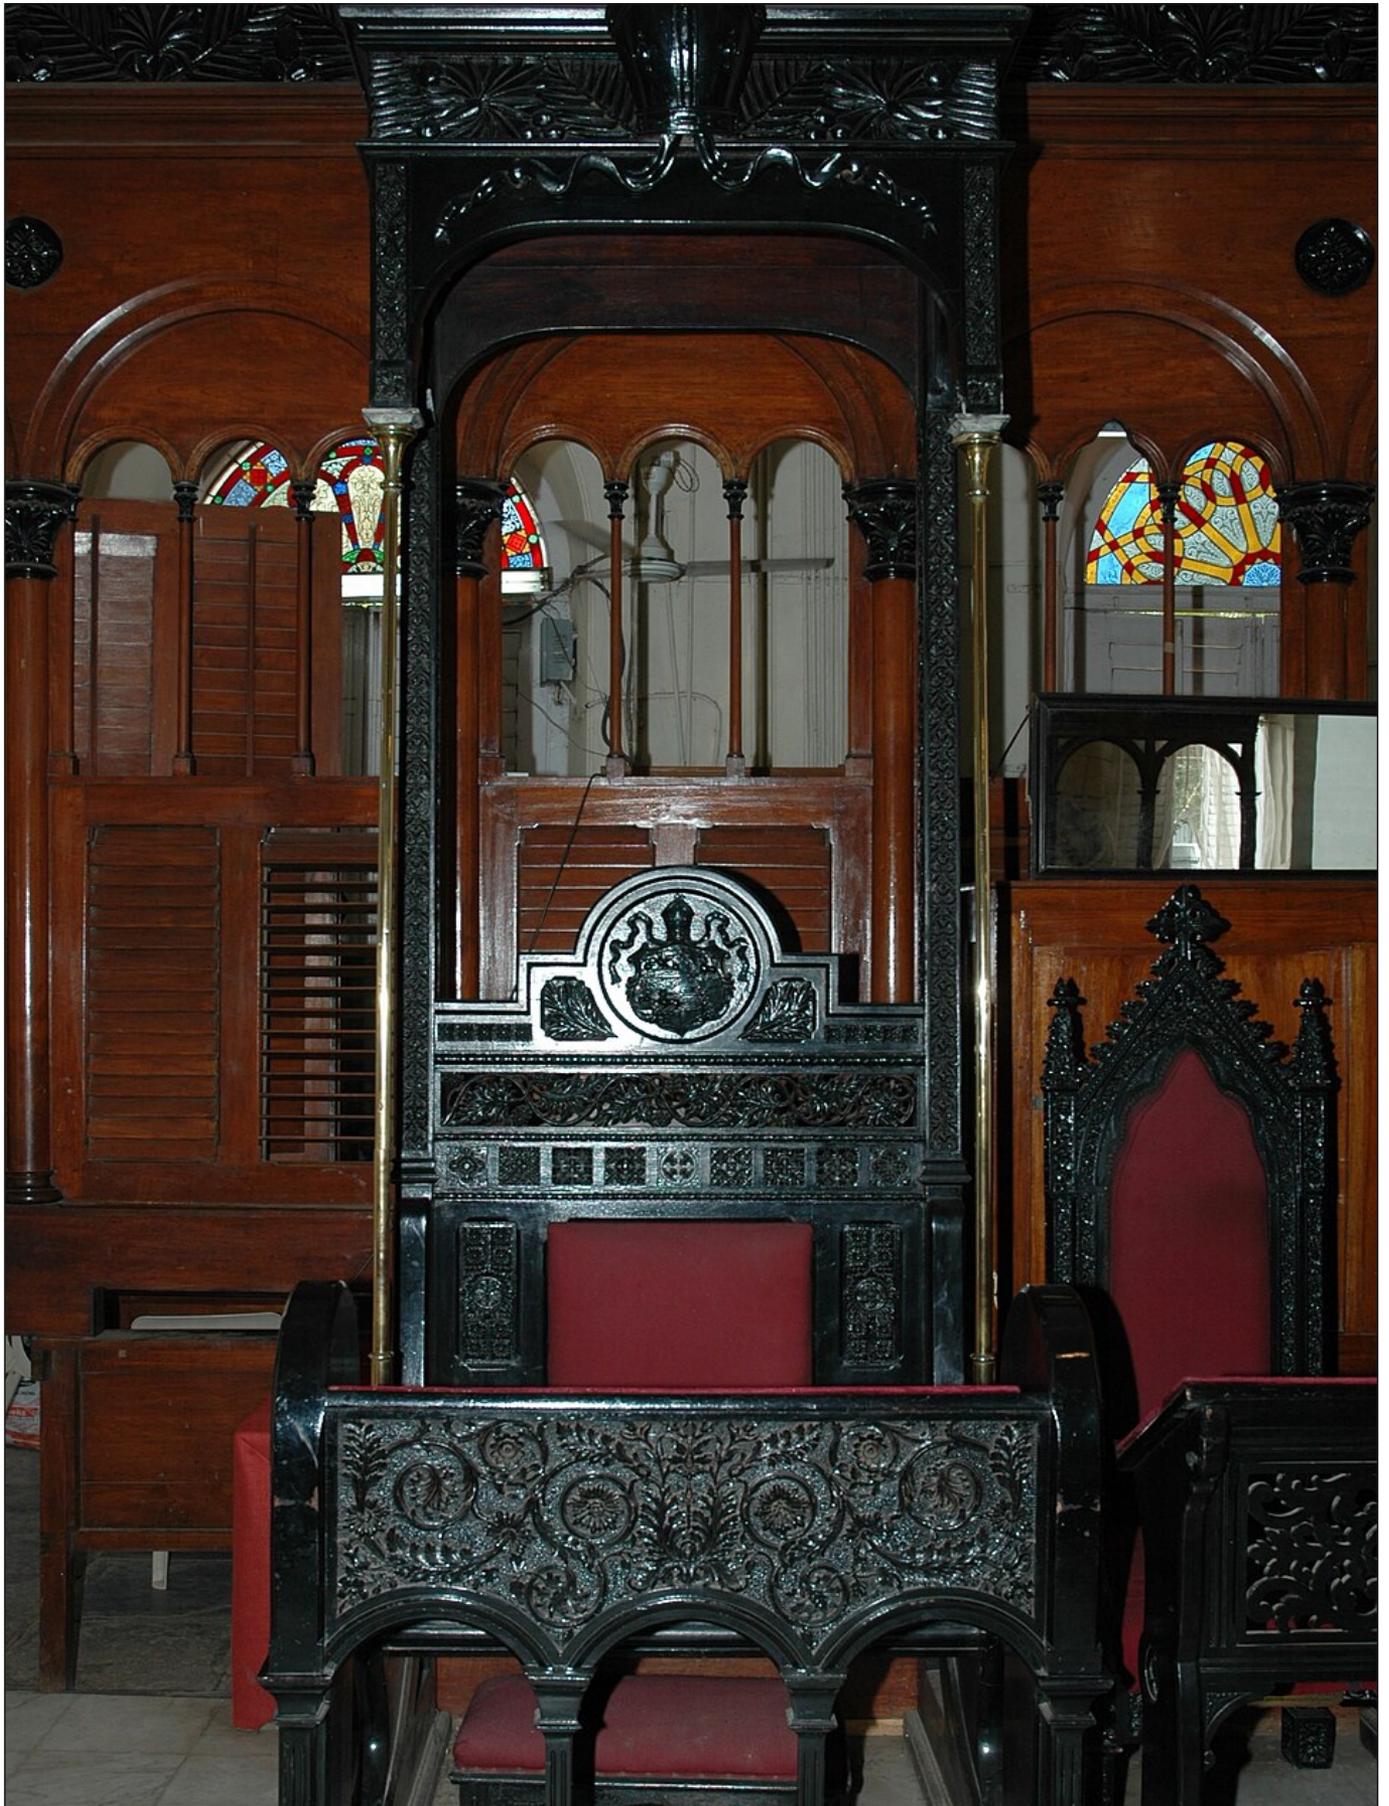
Stained-Glass Windows

Three types of stained-glass panels are found: large altar windows (510 × 150 cm), twenty upper wall panels on either side of the nave (163 × 110 cm each) and twenty-six semi-circular panels above doors and windows (163 × 85 cm each). Two panels had broken and been temporarily covered with plywood; others were cracked or had lost sections entirely. The total stained-glass surface area is approximately 110 sq. m.

In the early 21st century, several stained-glass windows were found damaged and replaced with imitation stained-glass panels. These replacements accumulated dust, dirt, and paint drippings over time and required cleaning. Five imitation stained-glass panels were severely damaged and were removed, cleaned, and restored by joining broken glass pieces, refitting flat lead comes, and sandwiching the designs between annealed glass sheets.

The original stained-glass windows above these imitation panels were found with cracked or broken glass and damaged, twisted lead comes. These were dismantled and restored. Broken glass pieces were removed, designs were redrawn and fired in a kiln, and the restored sections were reinstalled in their original positions. Gaps were filled with putty to prevent water ingress. Lead comes were blackened with paint and securely fixed to the iron framework of the windows.

Initially, it was believed that the three main stained-glass windows could be restored *in situ*. However, closer inspection revealed heavy deposits of dirt and corrosion on the exterior, along with cracks, missing pieces, and deformed comes. The panels were therefore removed and laid on specially prepared worktables for restoration. After cleaning with brushes, distilled water, and *Extran* (a neutral soap solution), damaged glass was removed and replaced. Designs were redrawn and fired multiple times, as some panels required up to three firings to properly fuse layered pigments. Cracked larger pieces were stabilised with lead comes to retain the original glass.

Almost every panel had edge damage, requiring new edge pieces for reinforcement. Stainless steel supports were fabricated to hold the panels firmly. The lower panel of the central stained-glass window was made removable to provide access to lighting installed behind the reredos.

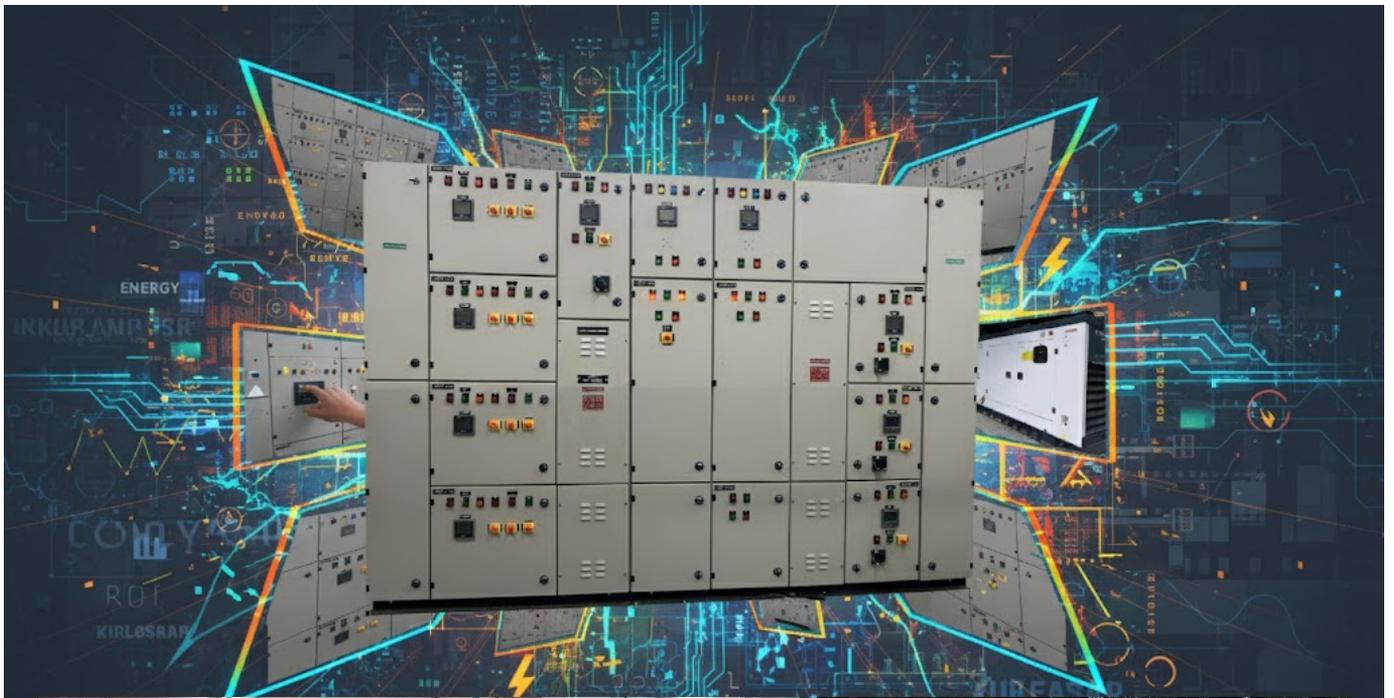
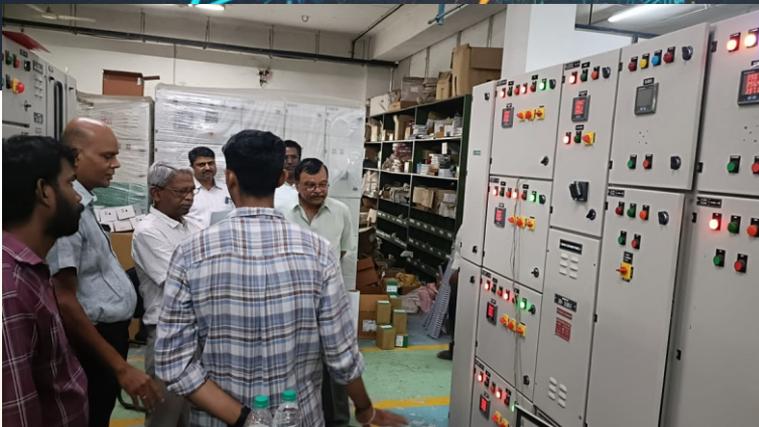
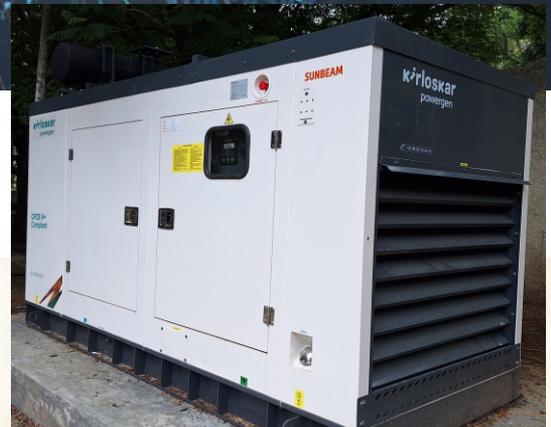
UPGRADATION OF THE ELECTRICAL SYSTEM

The electrical system inside the church mainly comprises the lighting, power socket system, fans, audio and video system, and air conditioners in the altar area and vestry. The entire wiring system, along with the distribution boards, has been replaced. Exposed conduits were replaced with a concealed raceway system wherever possible. Some of the chandeliers inside the church installed at a later date were different from the heritage type of the others. These were replaced with newly fabricated chandeliers designed to match the existing heritage ones so that they appear identical.

A larger number of power sockets have been provided within the church and at the porticos for convenient usage without excessive loose wiring. Although DG backup power has been provided to support the church's electrical loads, there would be a brief interruption in lighting and the audio-video system whenever EB supply failed before the DG starts automatically. To prevent this, UPS power has been provided for the internal lighting of the church, with battery backup ensuring continuous lighting until the DG starts. Similarly, the audio and video system has been equipped with an independent UPS to function without interruption. Existing fans have been reused after servicing and the incorporation of new bearings.

The bulk of the power supply for the church campus is provided from the Lloyd's Road EB feeders. To augment backup capacity, a new 125 kVA DG has been added, making DG backup power available to almost all loads. The existing EB panel was replaced with a new one. The 62.5 kVA DG panel was replaced with a new DG changeover panel accommodating both DGs. A PLC-based automatic operation has been installed to start the required DGs and supply the loads. A conventional hard-wired automatic system has also been provided to perform basic functions in the absence of the PLC. Automatic Transfer Switches (ATS) supply either EB power or DG power, depending on availability.
